West Lake Landfill Vicinity

Radiological Survey and Sampling

Interim Report

Hazardous Waste Program
Federal Facilities Section
January, 2016

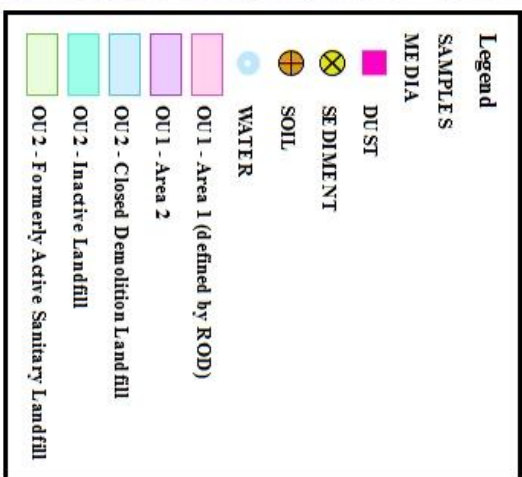
Figure 1: Map of Sampling Locations

Sampling and surveying was performed by four DNR personnel in groups of two. Where practical, specific soil samples taken from the sampling locations identified in Figure 1 were collected based on any noted fluctuations in the radiological surveying equipment. The ultimate soil sample collected therefore came from any location exhibiting the highest readings in any one area and thus biased the sampling as based on the field screening results. Recorded weather data during the sampling event was either estimated based on hourly meteorological data provided by the DNR station located off of St. Charles Rock Road to the east of the site, or local data reported from a weather mobile phone application. Hourly meteorological data has been included in Appendix E.

Procedure: Equipment B and D were utilized to obtain instantaneous gamma readings for an overall assessment of the range of gamma activities at all sample areas identified in Figures 1 through 6, except sample location S03 and S06 due to the dense vegetation present in those areas. Some areas were scanned several times during this sampling event. Photograph 2 shows a gamma survey being conducted at Spanish Village Park.

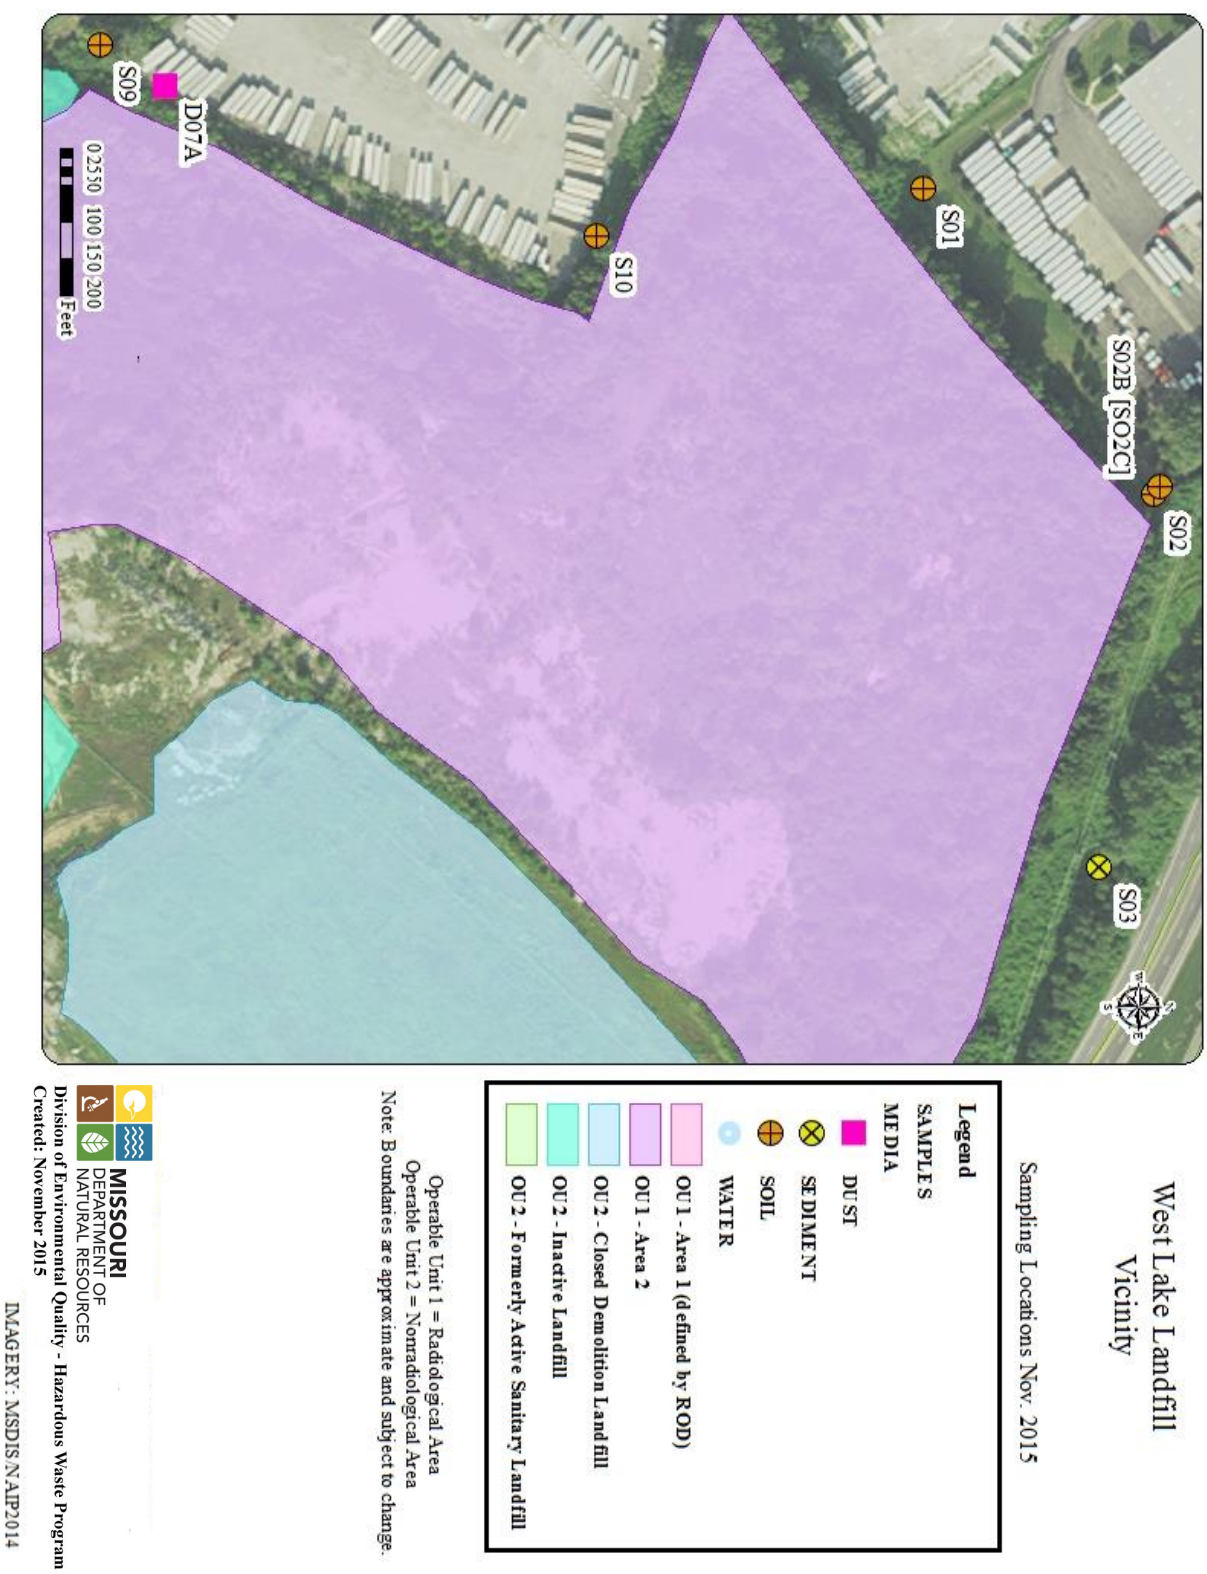
Figure 2: Sampling Locations North of Area 2

Results: No difficulties were encountered with the field measuring or sampling tools. Of the areas selected for soil sampling, locations S09 and S10 (Figure 2) were substantially moved from the original location selected during field reconnaissance. The appearance of sediment accumulation conditions at the new S09 location provided a biased sample opportunity. Sample location S10 was moved due to the presence of a thick asphalt cap, with the final location selected based on the gamma survey field screening.

As noted in Section 3.2, two sample locations S02 and S10 exhibited limited areas of persistent gamma readings. For sample location S02 located north of Area 2, we note that soil in this area appeared to contain notable crushed red brick debris which may have contributed to the comparatively more elevated gamma readings, so an additional more segregated sample (S02B) was collected in an effort to determine the elevated gamma reading source. These sample locations may still be on site property, as they were at the perimeter of the facility and neighboring private property. All samples, including a quality control duplicate sample S02C, were sent for laboratory analysis, and results will be available in the final report.

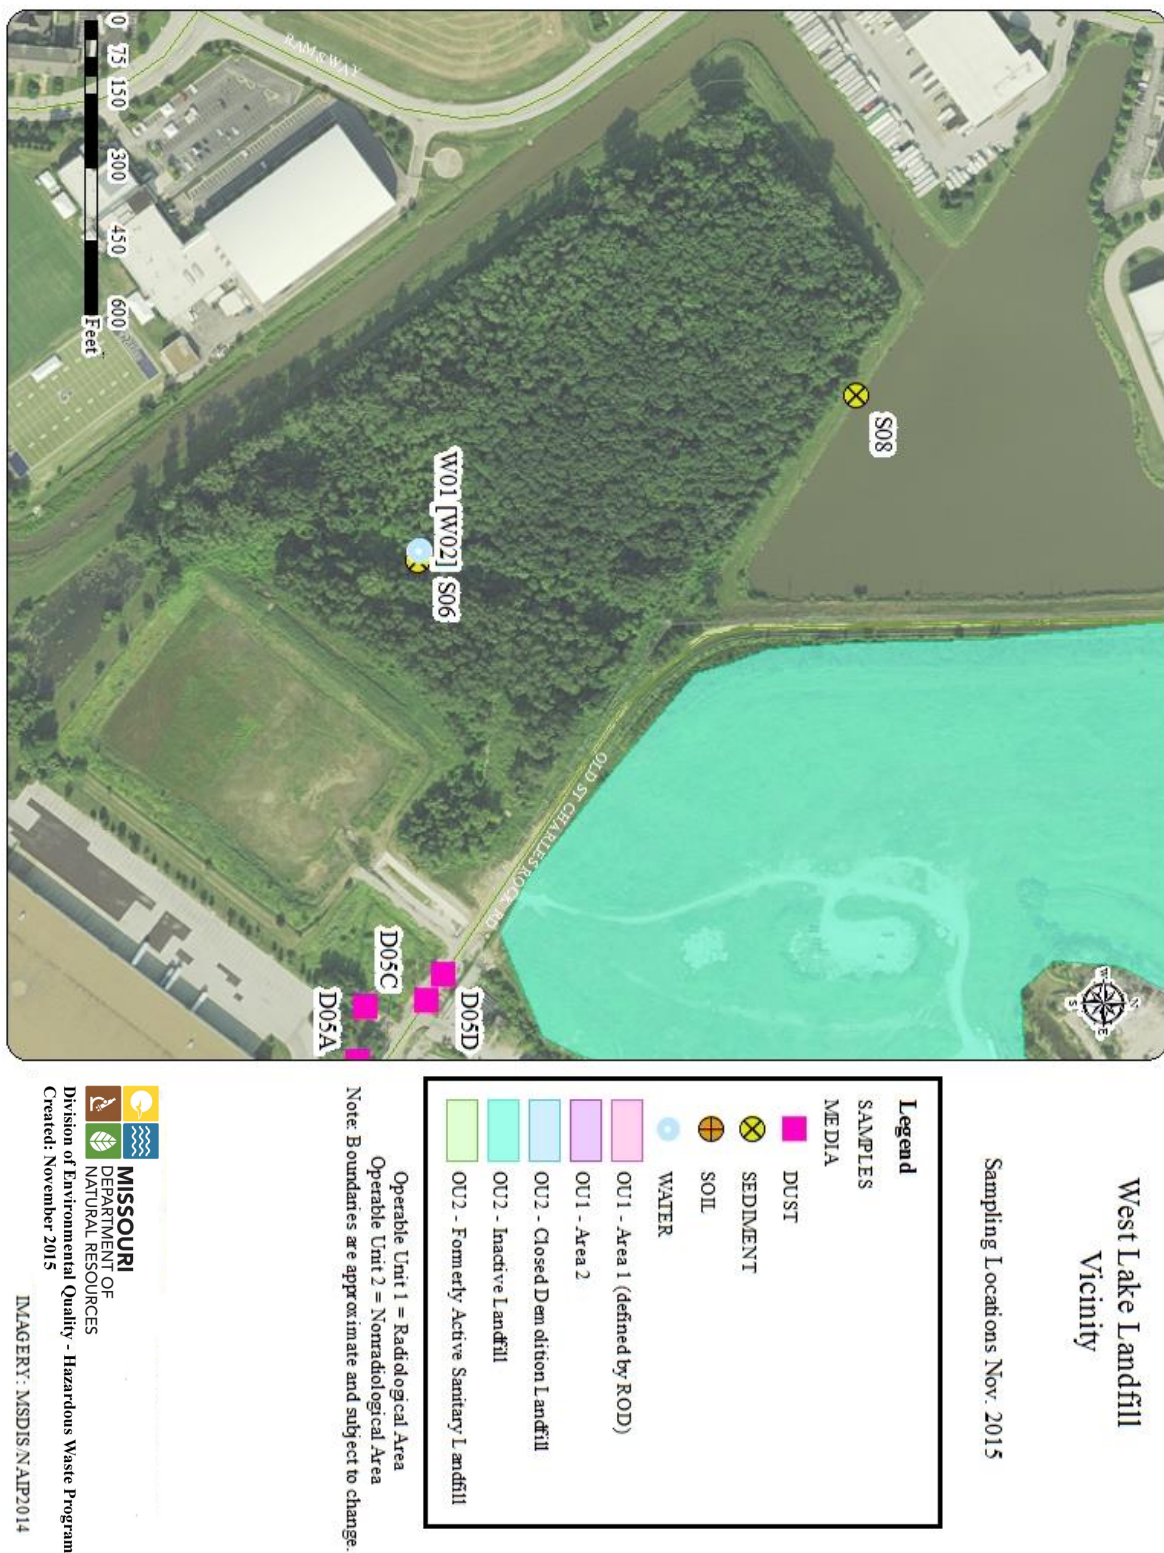
Figure 6: Sampling Location in Wooded Area South of West Lake Landfill

Results: The water samples were obtained in the wooded area southwest of the site where water had collected during the rain event. No problems were encountered during sampling. Samples were sent for laboratory analysis, and results will be available in the final report.

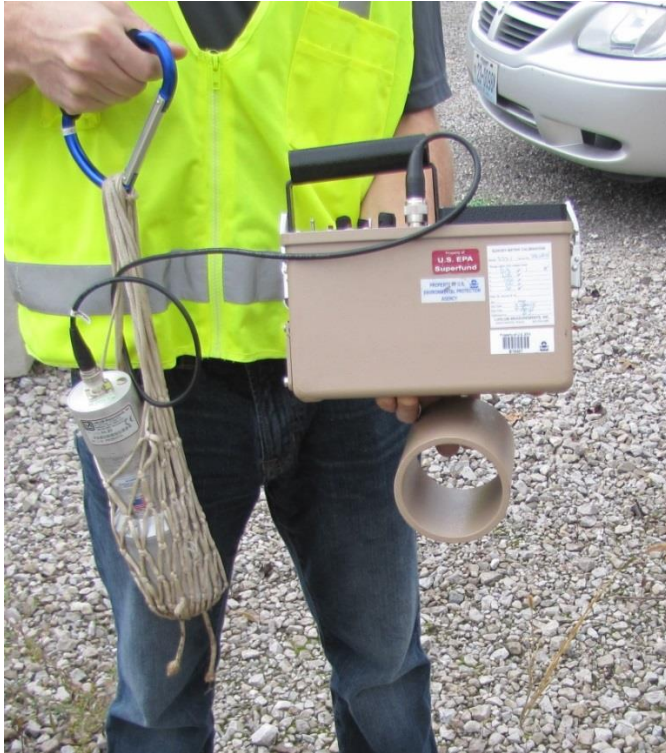
EPA Equipment Y: Ludlum model 2221 with 44-20 NaI Gamma Scintillator detector – This field equipment was brought by and periodically used by EPA personnel at some sampling locations(Photograph 1.)

Photograph 1: EPA Ludlum 2221 with NaI 44-20 detector and directional shield attachment (EPA Equipment Y)

EPA Equipment Y: Ludlum model 2221 with 44-20 NaI Gamma Scintillator detector – The 44-20 detector has higher detection sensitivity than Equipment B, making it well suited for survey applications (Photograph 1.)

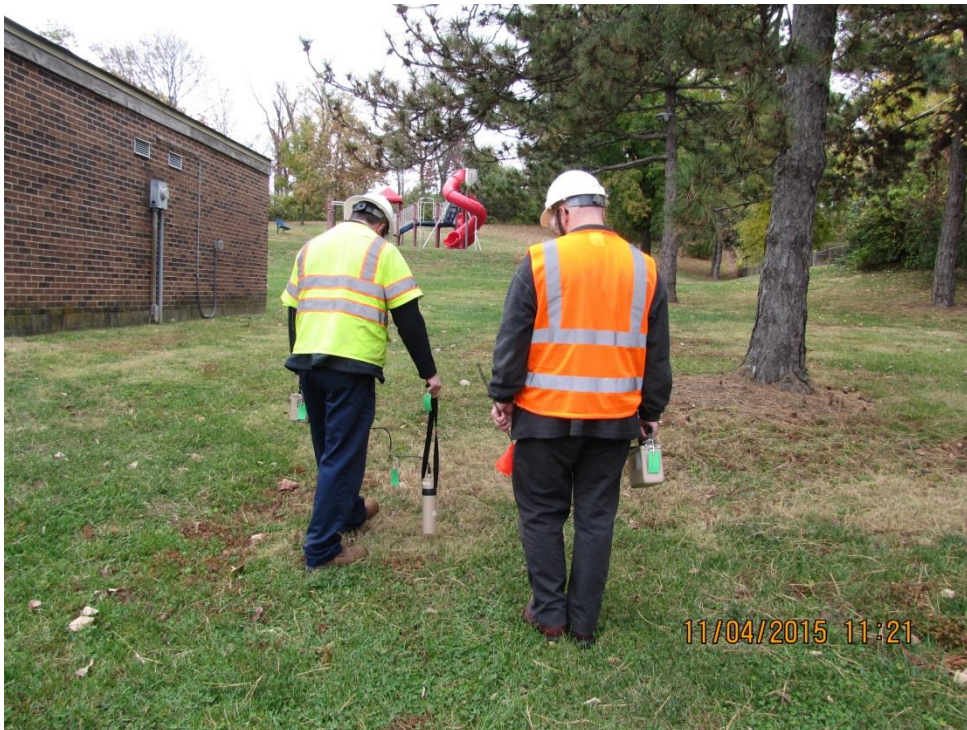
Photograph 2: Gamma walkover survey conducted at Spanish Village Park

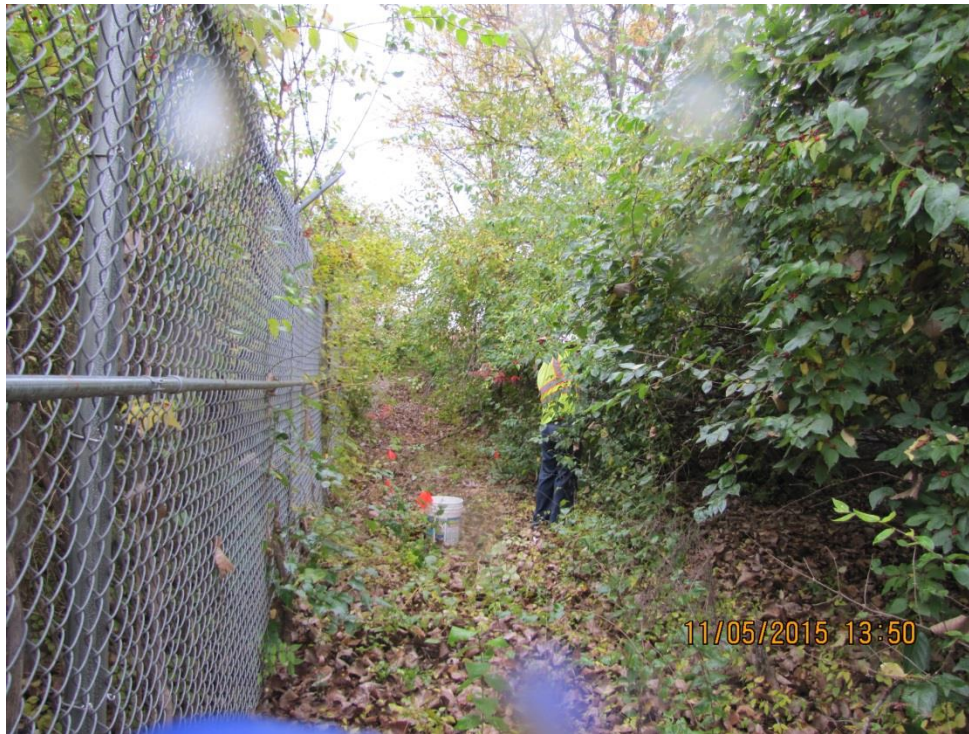
Procedure: Equipment B and D were utilized to take area-wide instantaneous gamma readings of each soil sample location where practical. Locations that had gamma readings in the higher end of each area range were then flagged for 1-minute gamma measurements using Equipment B. Up to five 1-minute measurements were taken and the location with the highest measurement was selected to collect the soil samples.

Photograph 3: One minute count being conducted on equipment B following gamma survey of immediate area. These locations are flagged in preparation of final soil sample location S09

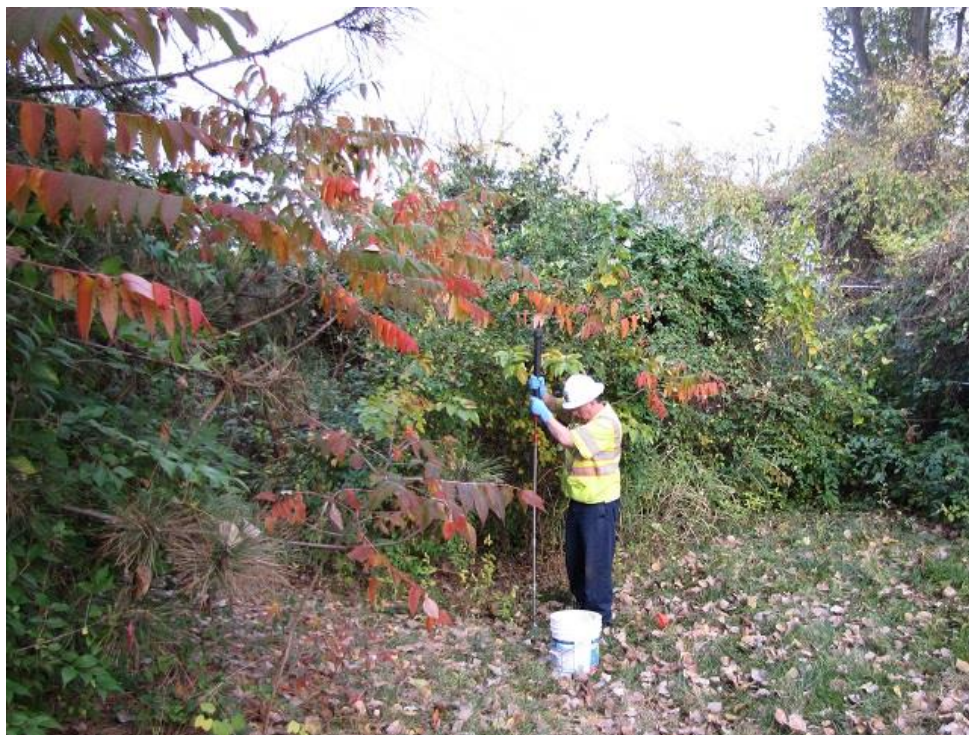
Surface soil and sediment samples were collected using a slide hammer and split spoon sampler fitted with a plastic sleeve. The resulting sample, encased in a 2-inch diameter by 6-inch long plastic sleeve, were sealed on each end with a plastic cap then taped. (Photographs 3 - 5)

Photograph 4: Soil sampling with Split Spoon sampler

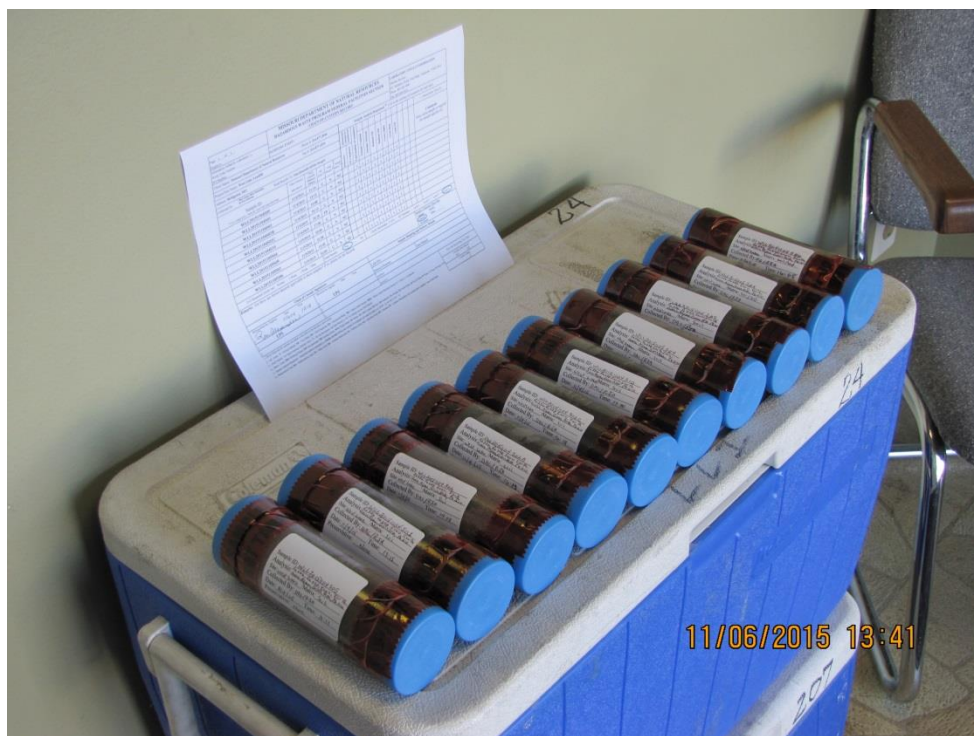
Photograph 5: Soil and sediment samples collected on November 4, 2015 being prepared for shipment

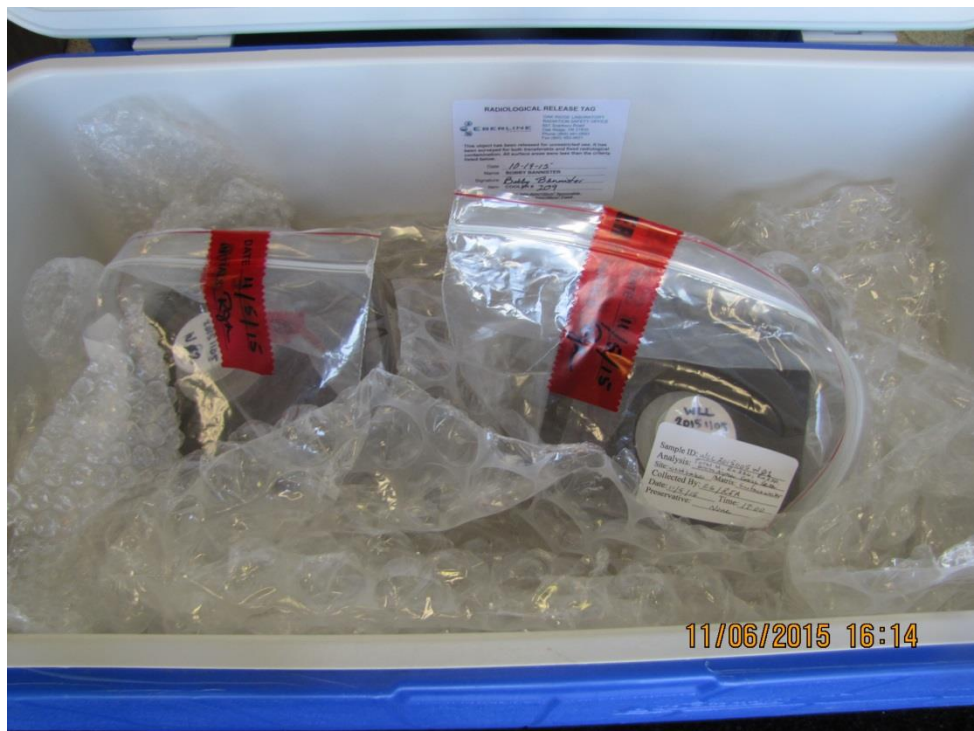
Procedure: One surface water sample and one duplicate quality control sample was collected into 4-liter cubitainers for laboratory analysis. Photograph 6 shows some of the samples being prepared for delivery.

Photograph 6: Surface water samples being prepared for shipment

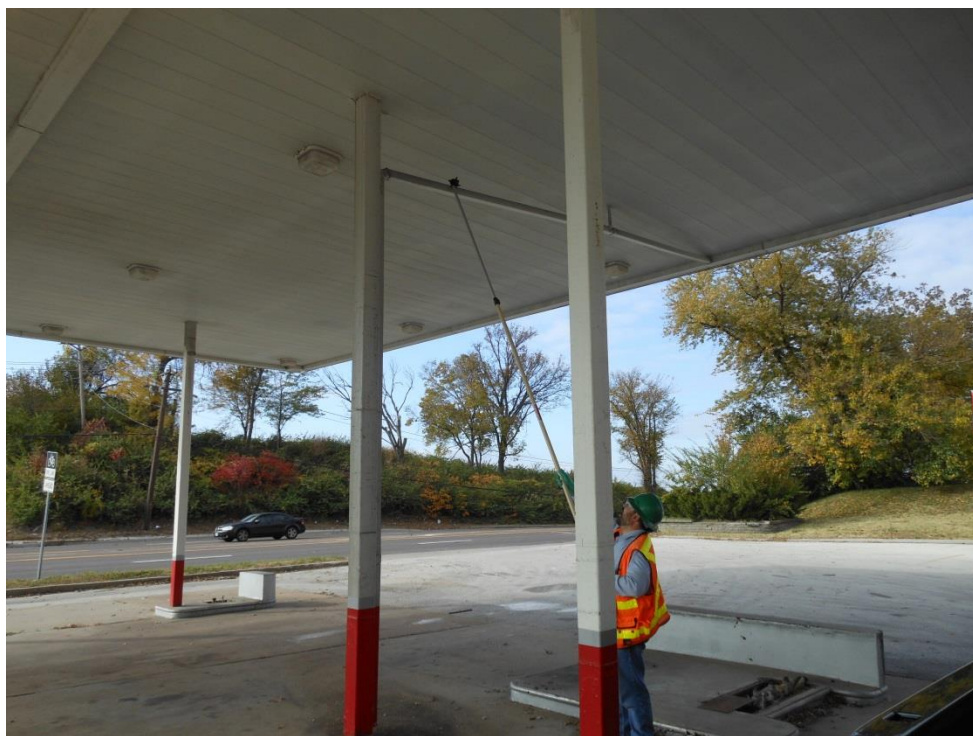
Procedure: Dust swipe samples were obtained at each selected area using standard cloth swipes. A preliminary alpha scan of each swipe was performed using Equipment A prior to analyzing the swipe samples on Equipment E for 10-minute count duration alpha and beta plus gamma counts. Samples that showed variable results from Equipment E were analyzed several times and all results are listed in Table 1. Quality assurance data is provided in Table 2. Photographs 7 and 8 show examples of dust sample collection and measurement.

Photograph 7: Collection of dust swipe sample D02A

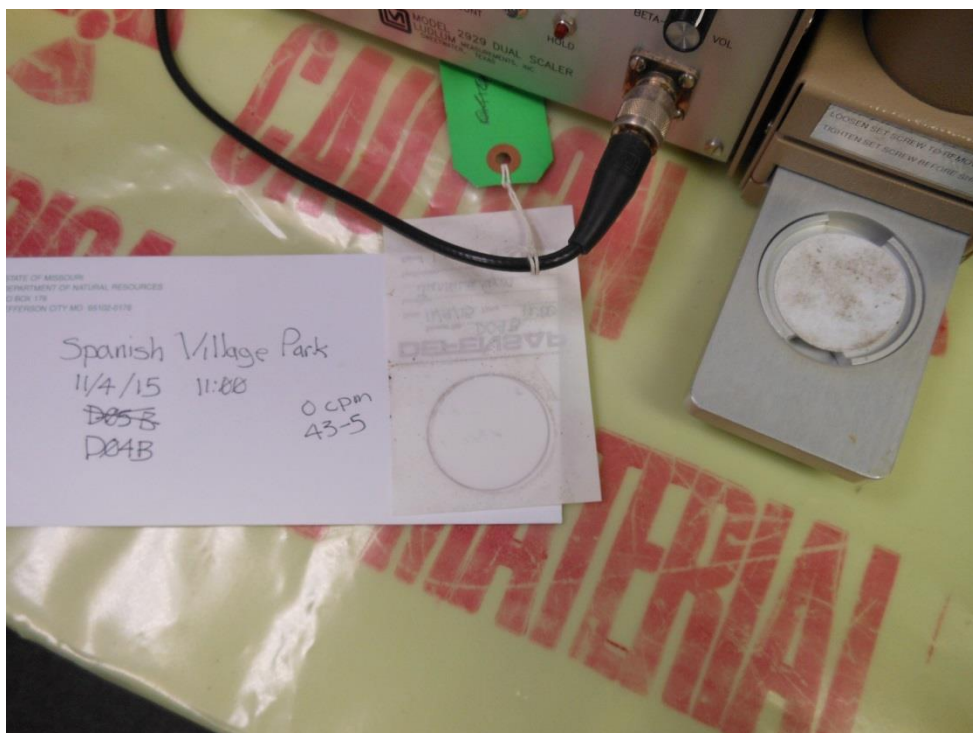
Equipment E: Ludlum model 2929 with 43-10-1 swipe counter - This bench top meter was used to perform alpha counts and combined beta-gamma counts of dust swipe samples. A Thorium 230 check source was periodically used to confirm equipment response.

Photograph 8: Testing of Dust Swipe Sample D04B with Equipment E

Equipment E: Ludlum model 2929 with 43-10-1 swipe counter - This is a bench top meter and probe designed for counting swipe samples. These samples are small cloth patches used to retrieve dust. Readings are in total counts for alpha and combined beta gamma so readings need to be divided by the duration of the count in minutes for a CPM value.
